# Large Scale Outdoor Fire Demonstration Program

**July 17, 1998**

**Greenstone Industries  
(now U.S. GreenFiber)**

**Steven Winter Associates, Inc.**  
Buildings Systems Consultants  
50 Washington Street  
Norwalk, CT 06854  
(203) 857-0200

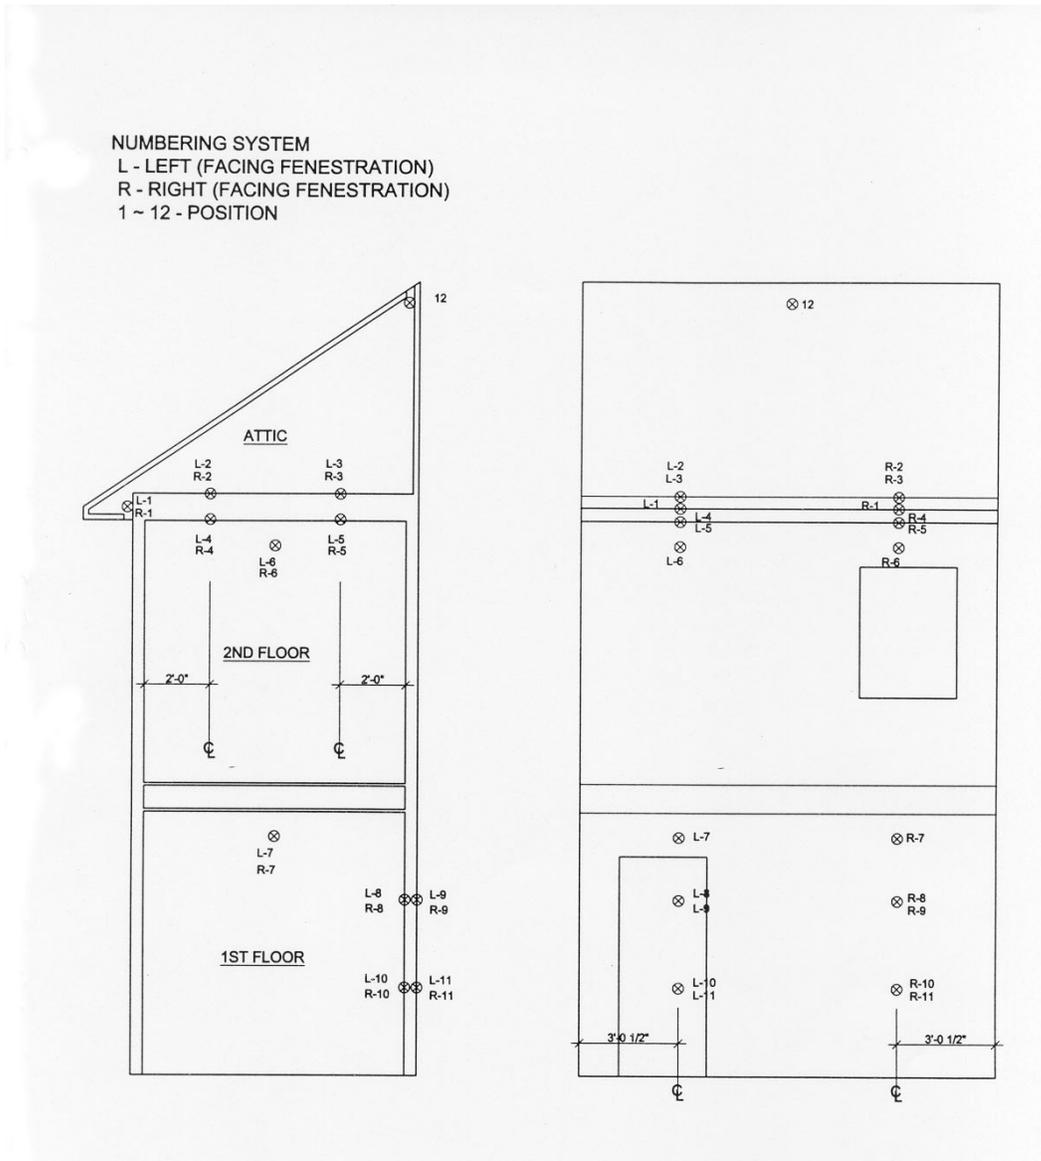
**Figure 3A: Thermocouple Diagram**

A total of (66) 20 Gauge Type K thermocouples and high temperature resistant wiring were used to document the specific temperatures of both lateral and interstitial points throughout two sections of each unit and as indicated on diagram Figure 3A.

Each unit was instrumented with two independent channels, designated as left and right, whose data was collected by two independent data acquisition devices (Campbell Scientific CR10X). Thermocouple locations may be generally categorized as wall, floor and air. Wall thermocouples were placed as pairs at the 2’-8” and 5’-4” heights centered between the width of the exterior wall cavity. Each pair was divided; one thermocouple placed adjacent to the gypsum board and one placed adjacent to the OSB sheathing. This configuration occurs at a total of four points within a single elevation at the exterior wall cavities. A plastic electrical receptacle was installed at 1’-6” height within the same cavity. The intent of the wall thermocouples was to identify the rate of fire spread both vertically through the wall cavity and laterally through the wall assembly between adjacent spaces. Air temperatures within each structure are measured 6” from the ceiling on both the right and left channel at both the first and second stories. Air temperatures in the attic space were measured at both the right and left side of the soffit and at a single location 6” below the center of the ridge vent. Air temperatures provided a quantitative measurement of the rate of fire spread/growth for not only the wood crib designed to approximate the furnace temperatures prescribed in the UBC Standard 7-1 (1994) but also the level of involvement at each story. The floor of the attic was instrumented at both the top and

bottom side of the 2 x 4 bottom chord of the roof truss. The floor temperatures provide an indication if the direction of fire spread is from below or above and/or from left or right.

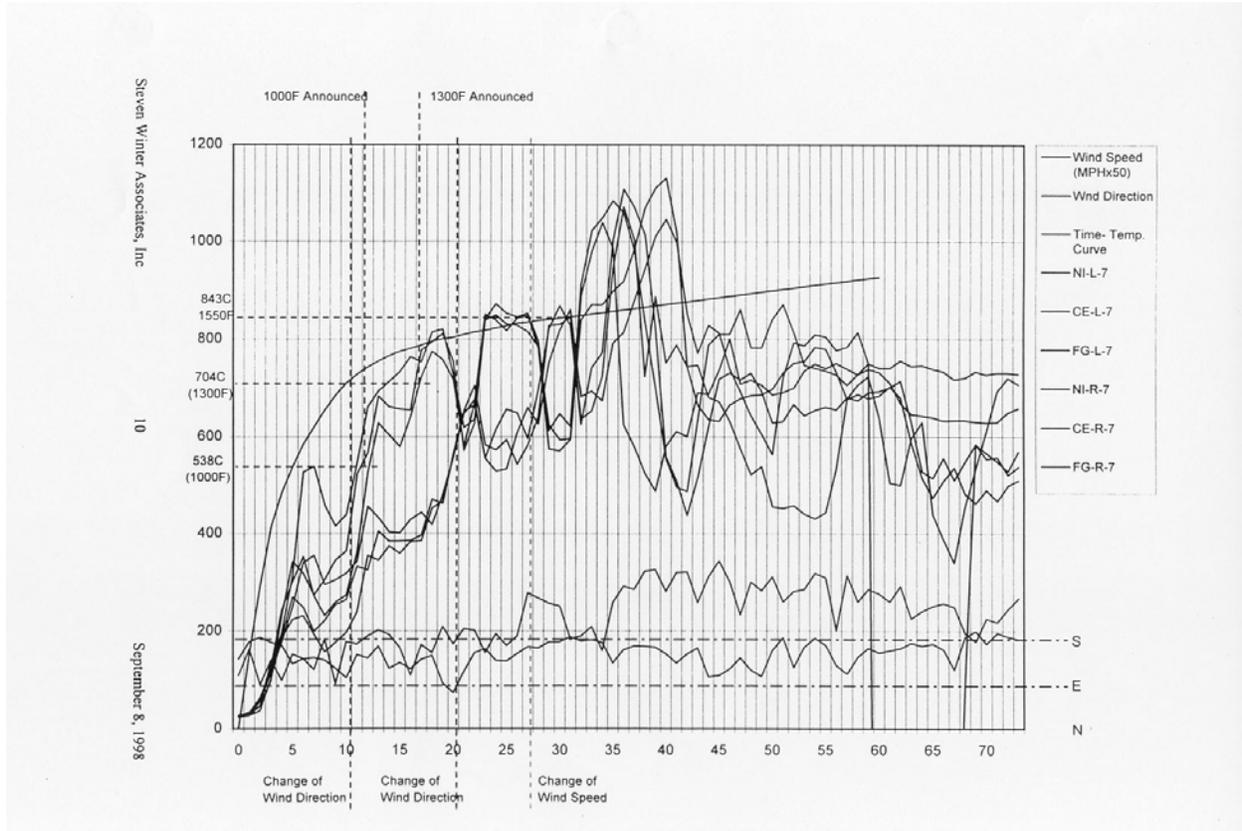
**Figure 4B: 1<sup>st</sup> Floor Air Temperature**

The wood cribs had been designed to simulate a residential light load room content fire of approximately 5 lb./sf. Southern Pine Fir members were assembled as per the requirements of UBC Standard 26-4 in the configuration as detailed by the construction documents. This crib produced temperatures that approximated the time-temperature curve prescribed by the UBC standard 7-1, at the 5, 10 and 30 minute marks. The temperature rise as measured by thermocouples R-7 and L-7 essentially reaches each mark within a minute of the designated requirement. The attached "First Story Air Temperature Graph," Figure 4B illustrates the variation of the temperatures from the ideal time-temperature curve as well as from each other within the same unit. The influence of both wind speed and direction are also identified on the graph. The maximum acceptable wind speed of 10 mph was never exceeded during the demonstration. These influences are reflected as dramatic momentary changes in temperatures uniformly affecting all units. Both the left and right channels are identified in this graph and form in essence two distinct groupings affected by the proximity to the wood crib, which is asymmetrically located within the space. Each grouping of channels closely approximates each other and demonstrates the uniform development of all wood cribs at essentially the same time.

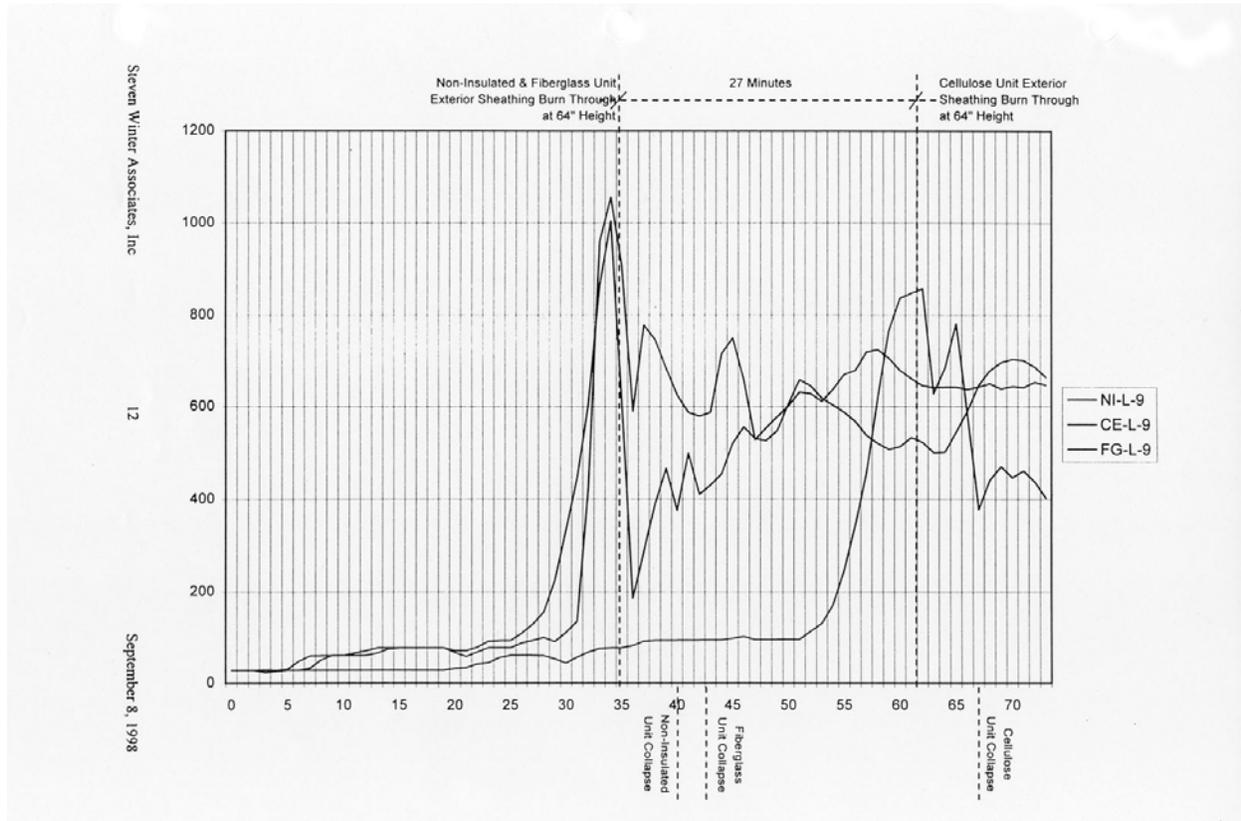
**Figure 4C: Temperature at L-9**

The same point at each unit is graphed so a comparison can be made as to the progression of fire, both vertically and laterally. Visual observations from the video log are identified on the graphs where appropriate. Interpretation of the graphs may be made by identifying the time difference between units for the temperature to rise to a level supporting combustion. An example of such an interpretation would be the resistance demonstrated by thermocouple location L-9, Figure 4C,

the interior surface of the OSB sheathing. The non-insulated and fiberglass unit temperatures rose to 800° C at the 35<sup>th</sup> minute; however, the cellulose unit provided 27 minutes additional resistance before reaching the same point. At both points, the OSB continued to burn for approximately three minutes, and five minutes later the collapse of the structure occurred.

1. The cellulose unit collapsed 24:32 minutes after the collapse of the fiberglass unit. This represents an increased resistance in excess of 57% that corresponds well to the best results from laboratory test results of 55%.
2. The collapse of all three buildings occurs within 8 minutes of thermocouple location L-9 reaching 800° C. The cellulose structure provided an additional 27 minutes of lateral fire spread resistance. This lateral resistance proved to be the critical path precipitating collapse.
3. The maximum air temperature (approximately 1200° C) of the second story space for both the fiberglass and cellulose insulated units occurred within four minutes of each other, demonstrating where insulation is not present in the floor assembly, the progression of fire through the floor assembly is very similar among the units.

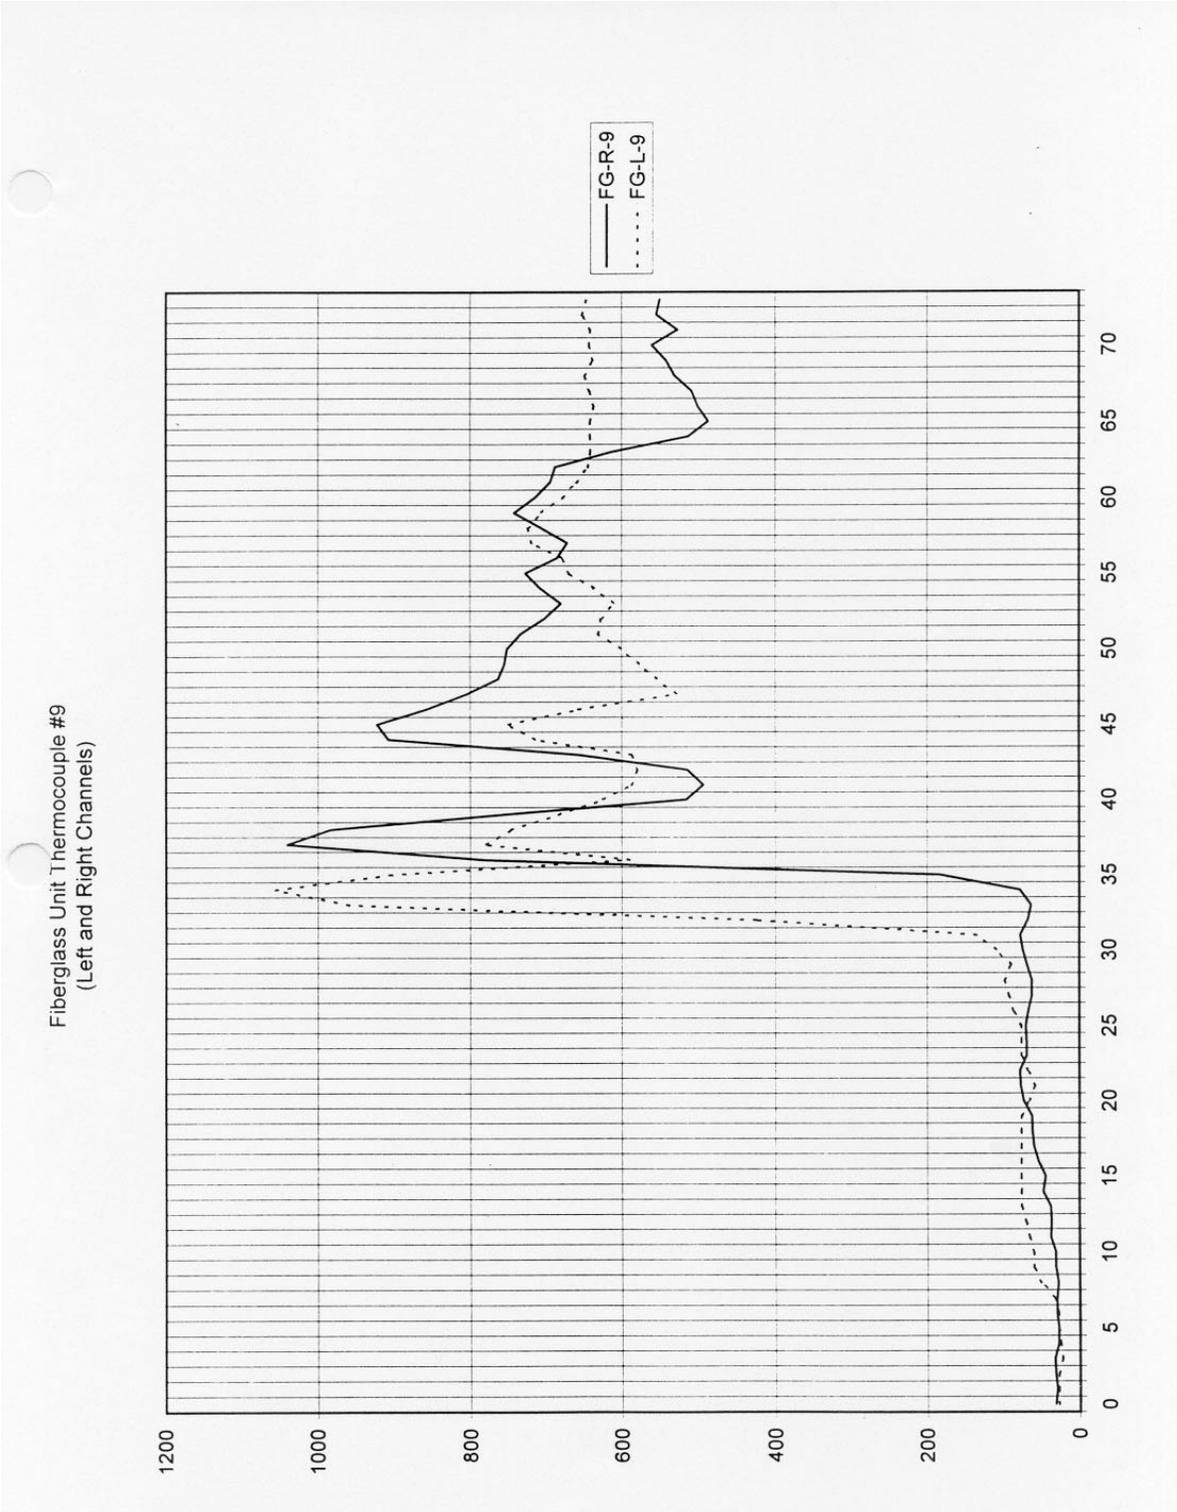
**Figure 4D: Left and Right Channel Correspondence**

Finally, both left and right channels at each point were examined for correspondence with each other. Thermocouples at the right channel of the non-insulated unit were not used at locates R1-6 and the thermocouple at point L-11 at the fiberglass unit failed. This analysis, as exemplified by Figure 4D, demonstrates very good correspondence between left and right channels with a slight time lag of approximately 2-3 minutes due to the asymmetrical placement of the crib. This redundancy of data provides a high measure of confidence in the comparison of a single data channel.

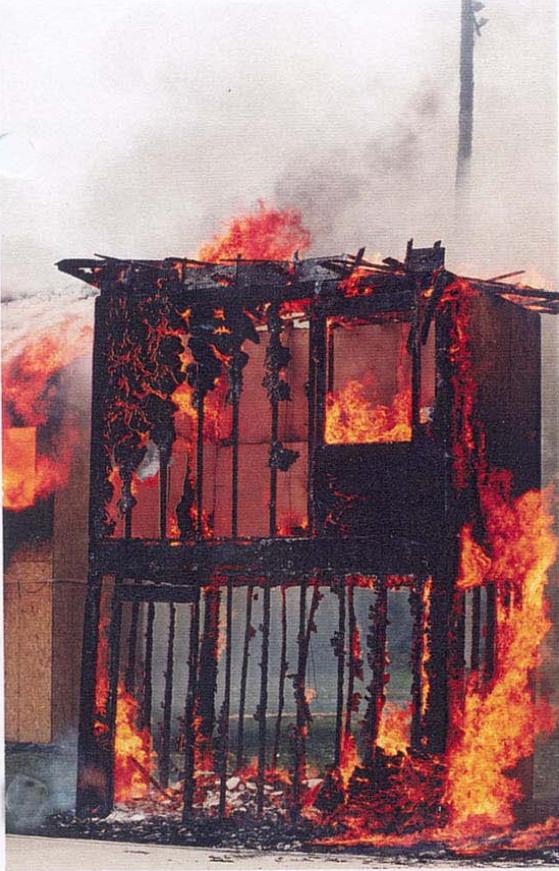
**Structure with no insulation collapsed 40:10 after ignition.**

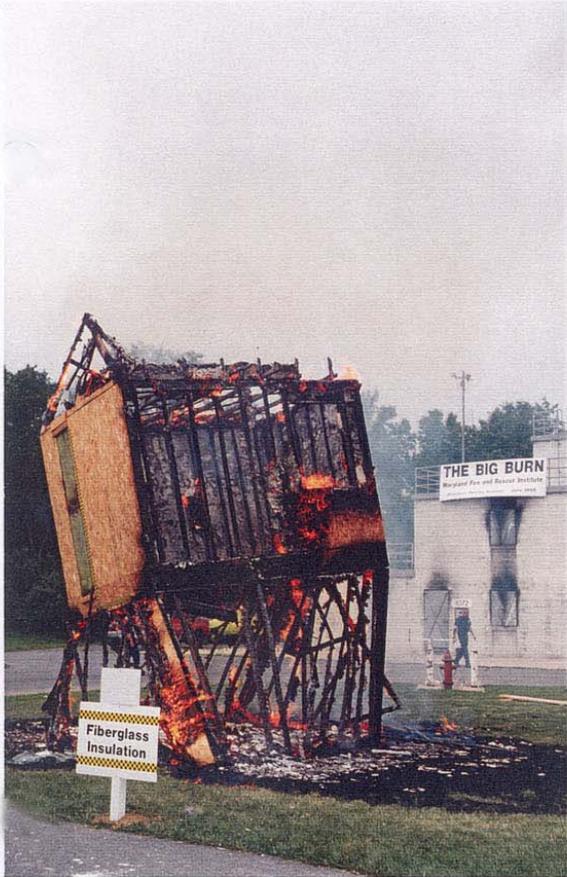
Structure with fiberglass insulation collapsed 42:26 after ignition.

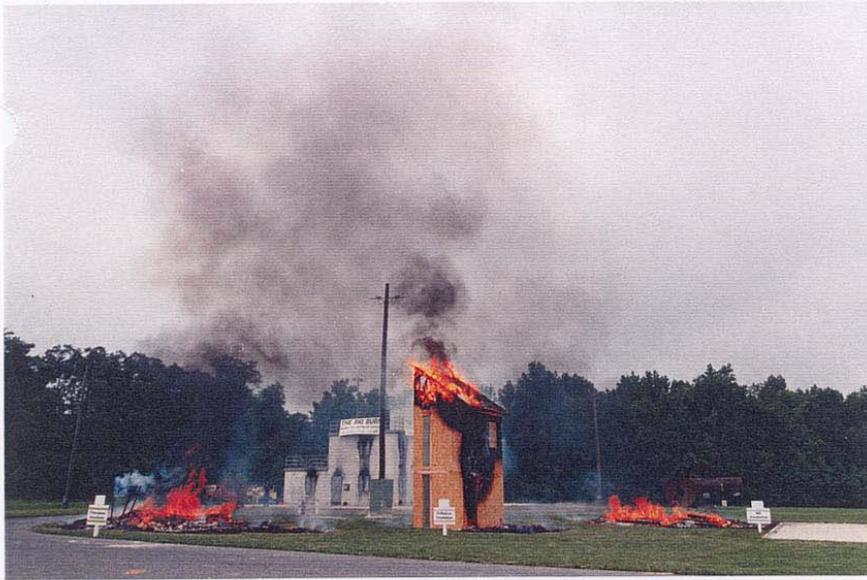
**Structure with cellulose insulation resisted the fire 57% longer than the fiberglass structure.**

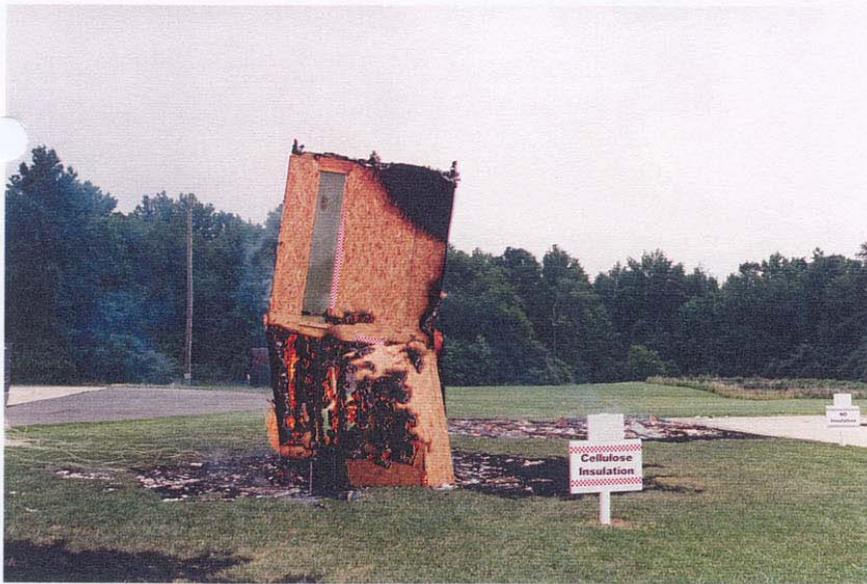
Structure with cellulose insulation collapsed 66:45 after ignition.
